STABILIZATION OF MOVING LAND MASSES BY CAST-IN-PLACE PILES

John B. Palmerton

Geotechnical Laboratory

May 1984

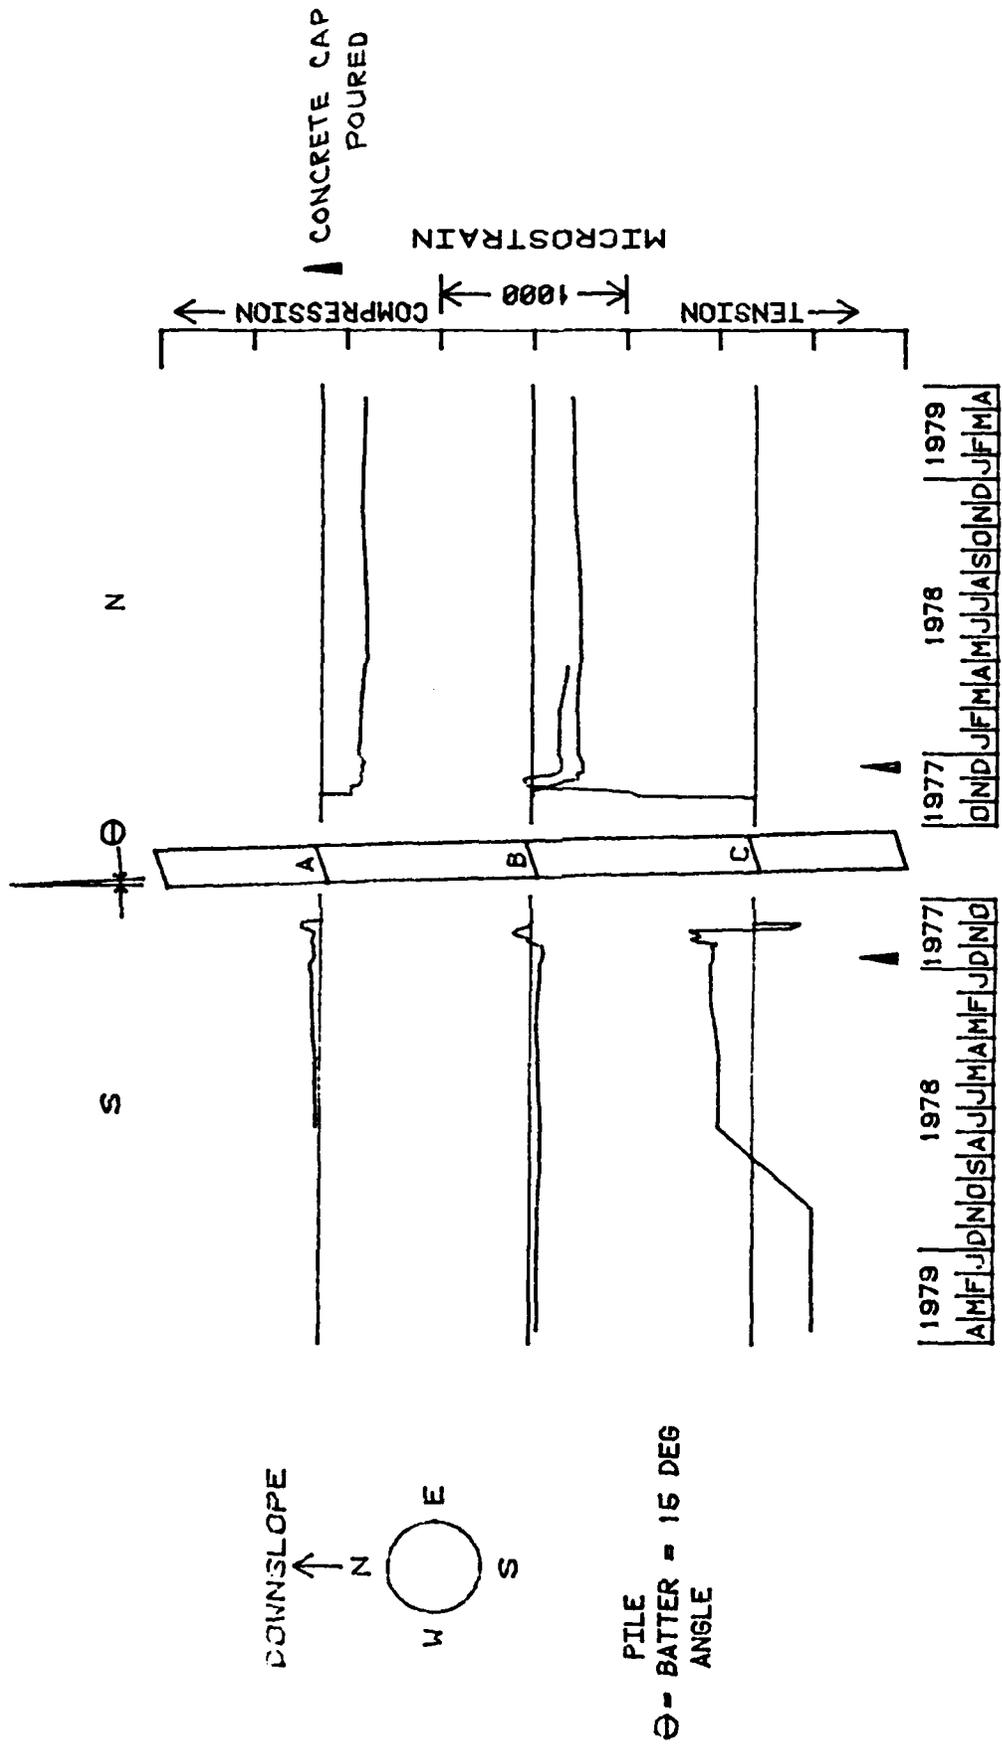
Figure 82. Strain-time histories along the length of pile 624

92. One feature which is consistent with all the data is the general relationship of gage output to the placing of the concrete cap. For example, see Figure 82. Gage output steadily increased in either tension or compression following pile installation but before construction of the pile cap. Shortly after the pouring of the cap beam, the gage response diminished and approached a constant level (in most cases).

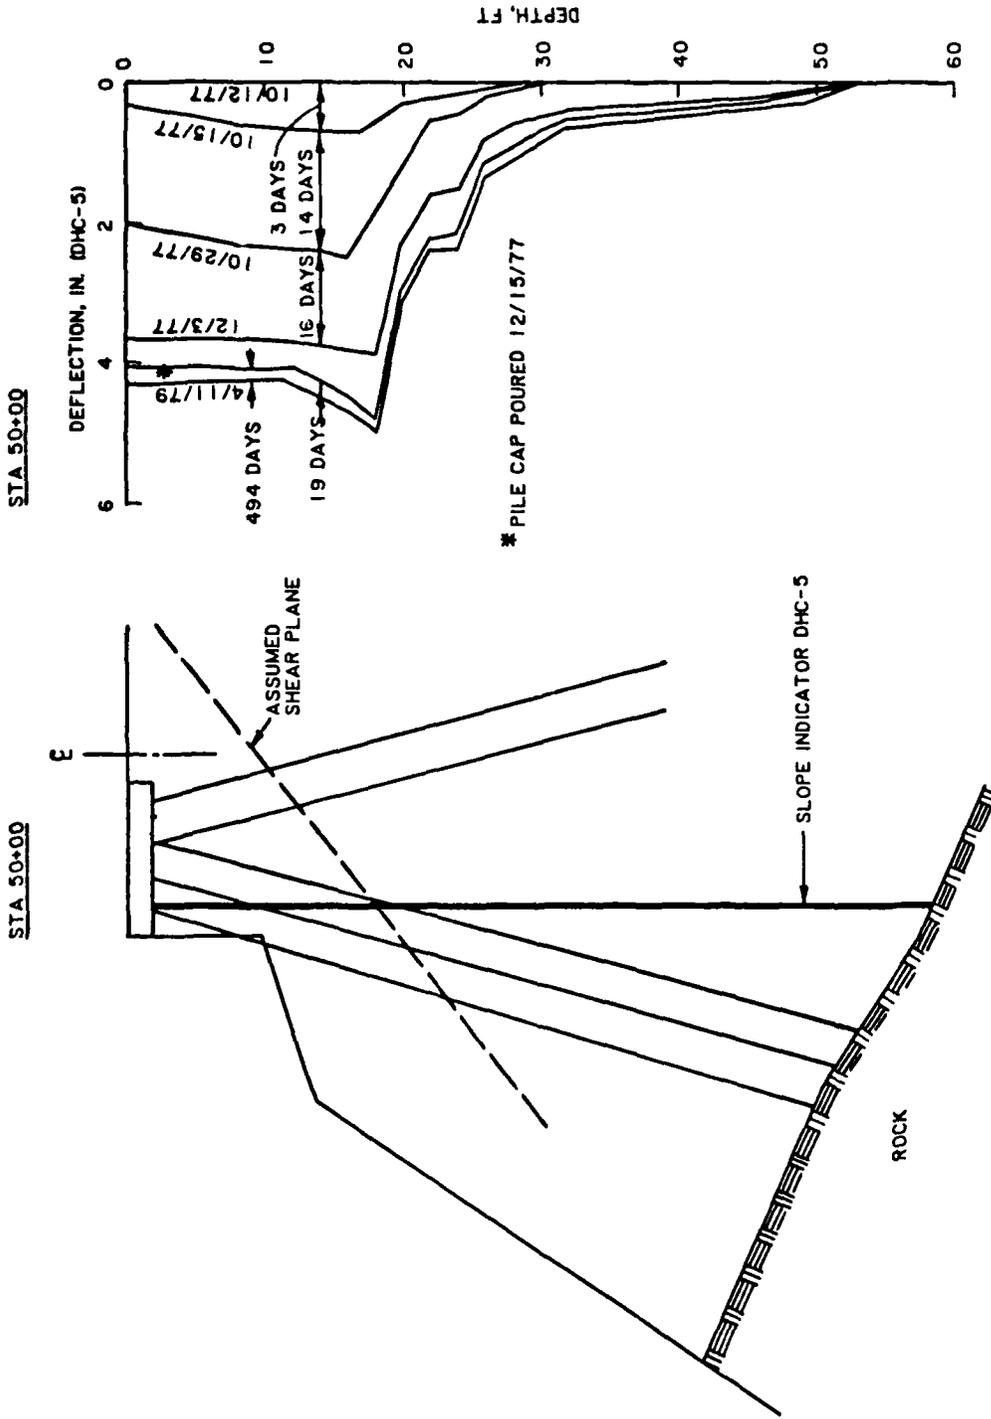
Figure 97. Slope indicator movements (Continued)

96. The slope indicator data presented in Figure 97a shows the development of a shear surface between depths of 18 and 24 ft at station 50+00. The maximum deflection recorded was 5.0 in. at the 18-ft depth. The slope indicator at station 50+50 (DHC-6) recorded a maximum deflection of 2.2 in. at the surface as shown in Figure 97b; however, a clearly defined shear surface is not as apparent as at station 50+00.

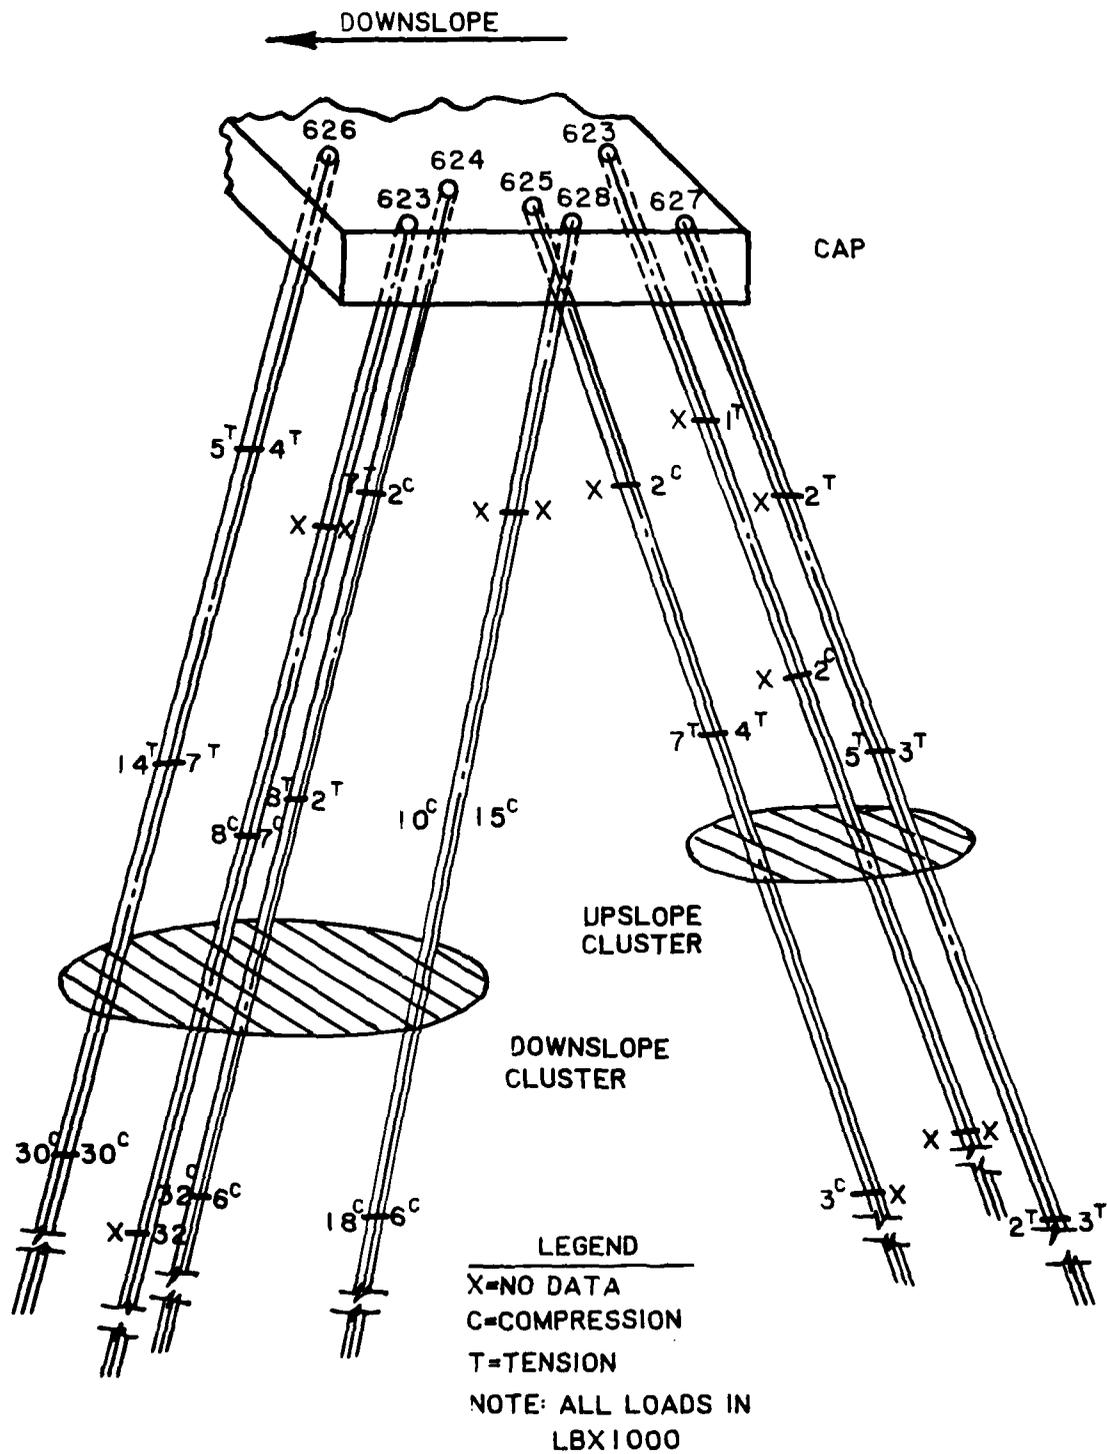
Figure 99. Strain gage loads

101. The postconstruction loads acting at the strain gage locations are schematically shown in Figure 99. For clarity, piles 623 and 627 are shown beside piles 626 and 622; however, in profile they are coincident. The axial load in each rebar at the gage station is (theoretically) the average of the individual readings at the gage station. The average axial load at each gage station (postconstruction) is shown in Figure 100. Ideally, the figure represents the loads within the "composite beams" formed by the upslope and downslope pile clusters. The design shear plane is also shown in Figure 100. The slope indicator data given in Figure 97b verify that the location of the design slide plane was essentially correct at least as to the depth of the maximum deflection. The slope indicator data do not indicate a single abrupt shear plane, but a rather wide shear zone extending from depths of 18-28 ft.

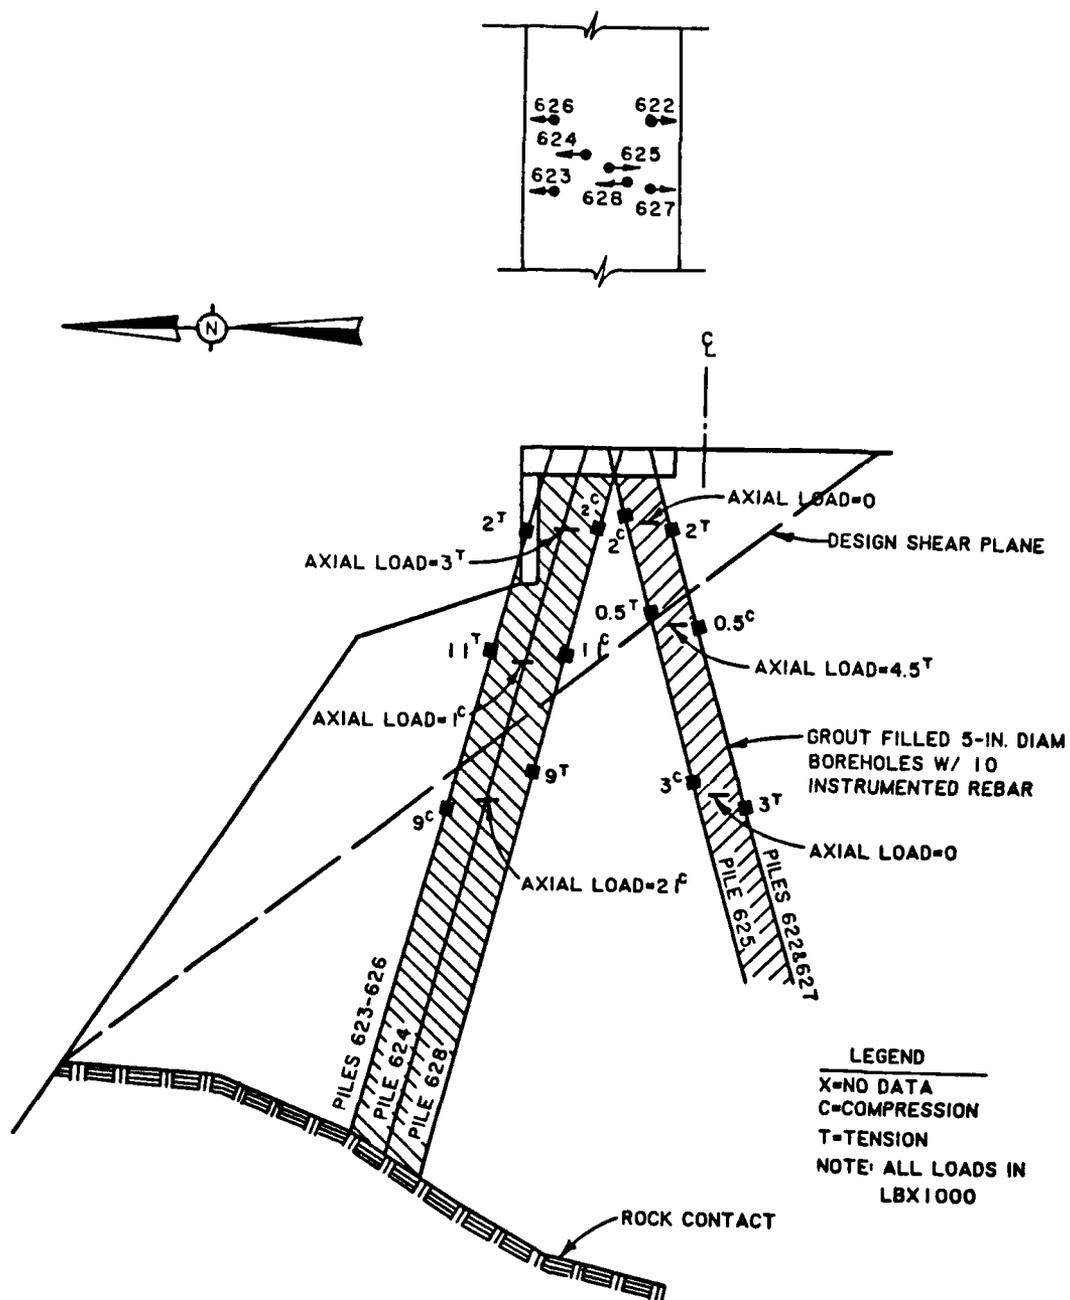
Figure 101. Interpreted bending and axial loads in "beams"

102. The loads within the composite beam due to pure bending may be calculated by deducting the average axial load from the outer fiber (outer rebar) loads. Figure 101 shows the interpreted bending loads and axial loads acting on the upslope and downslope "composite beams." There are an insufficient number of data points to accurately define the "beam" behavior; however, the load interpretation represented in Figure 101 is entirely reasonable when compared to the slope indicator data. Qualitatively, the interpreted bending loads would yield a pair of beams bent in the shape shown in Figure 102. This schematic interpretation is consistent with design considerations except for a reversal of the expected bending in the upslope cluster. Apparently, the forces in the downslope cluster (which includes tensile axial loads in the upper portions) are transferred through the pile cap to the upslope cluster causing the upslope "beam" to be pulled into the material between the pile clusters. The upslope "beam" also does not experience appreciable axial loading except for a tensile load in the vicinity of the design shear plane.
